## FEDERAL ENERGY REGULATORY COMMISSION FIELD INSPECTION REPORT

**Date** June 16, 2016

**Project** Southeast Supply Header, L.L.C.  
Southeast Supply Header Expansion Project  
Copiah County, Mississippi  
Docket No.: CP14-87-000  
Authority: Section 7(c)

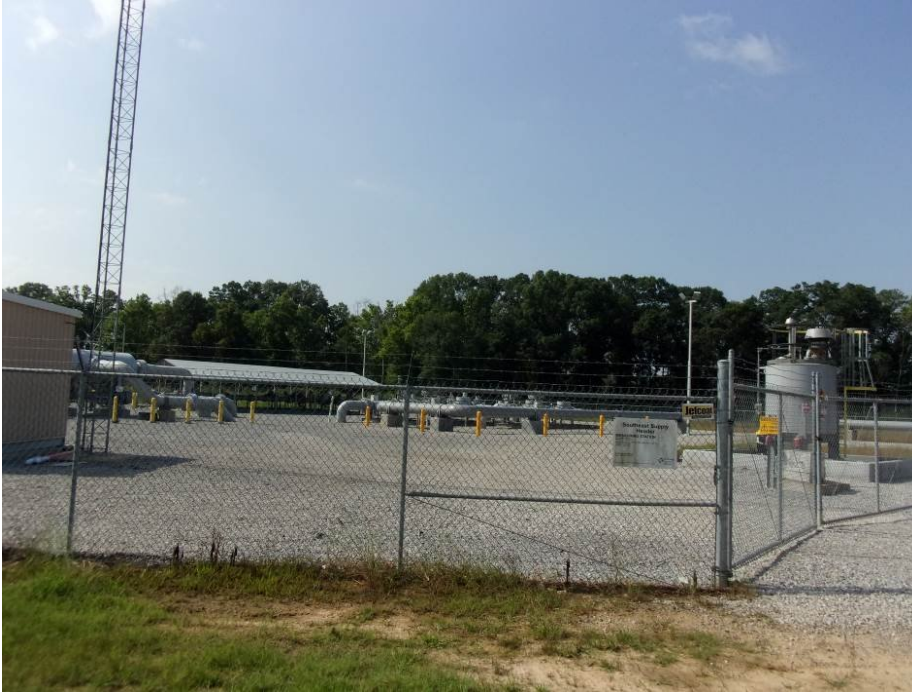
**Photo No.:** 1

**Assessment:** Acceptable

**Comments:** Aboveground Facility, SESH Meter Station. The site was restored and stabilized with gravel groundcover, and fencing was reinstalled to secure the perimeter of the facility. The previous workspace outside fenced site was returned to use by the landowner. A private gravel road was reconstructed along the western side of the facility. No environmental concerns were noted.

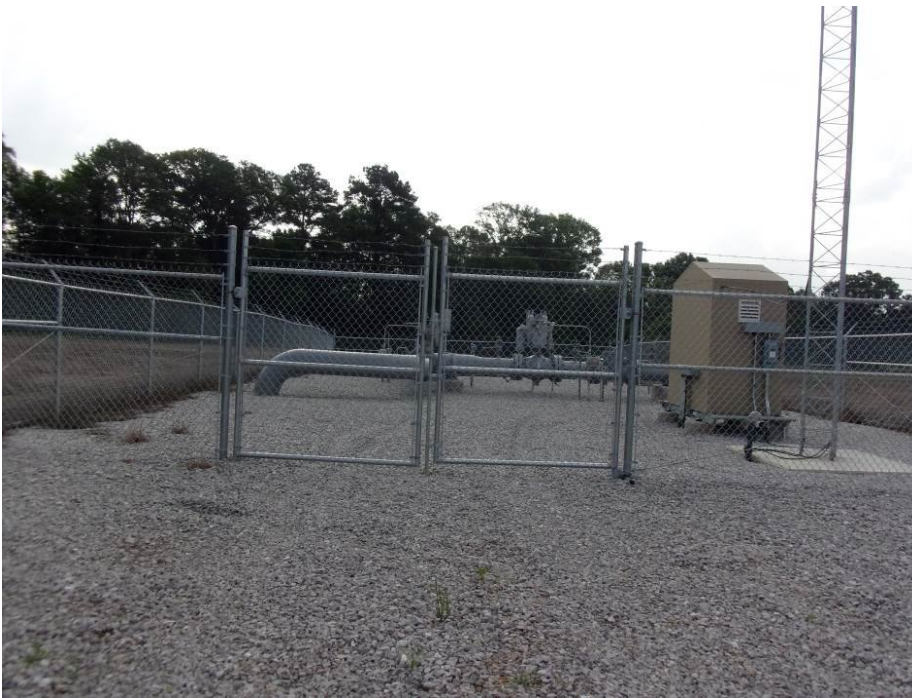
**Photo No.:** 2

**Assessment:** Acceptable

**Comments:** Aboveground Facility, Texas Eastern Valve Site. The valve site was restored and stabilized with gravel groundcover. Permanent site fencing was recently installed. The area outside the fenced site was in-use by the landowner. No environmental concerns were observed.

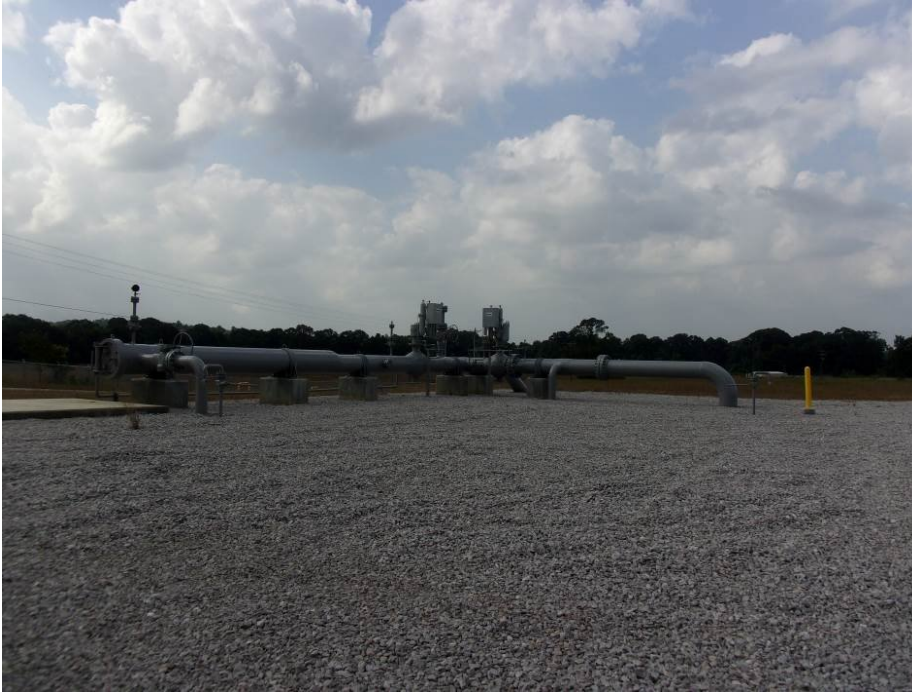
**Photo No.:** 3

The pig launcher<sup>1</sup> site, within the Dentville CS yard, was restored and stabilized with gravel groundcover (Photo No. 3). The perimeter and upper section of the site were restored and stabilized, with no erosion observed. The seeded annual vegetation was spent, but the yard was stable. Fencing was installed along the entire perimeter of the site (Photo No. 8). The contractor yard site was restored, stable, and well vegetated (Photo No. 9). A gravel-lined stormwater drainage channel was functioning properly, and gravel was installed to stabilize the hill within the site. The office/warehouse, motor control center, and compressor buildings were complete, and the sites were restored and stabilized with gravel groundcover (Photo Nos. 7 and 10). Overall, the site was clean and well maintained, with no off-ROW or environmental concerns identified.

**Assessment:** Acceptable

**Comments:** Agricultural ROW, Dentville CS, Pig Launcher. The site was restored and stabilized with gravel groundcover. A gravel-lined stormwater drainage channel was functioning properly adjacent to the site. No environmental concerns were identified.

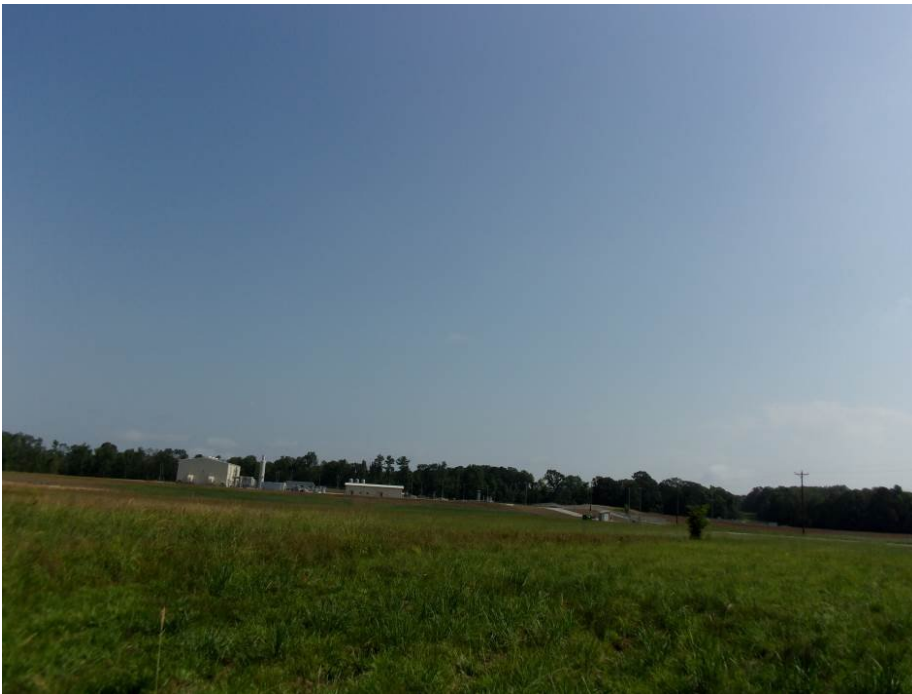
**Photo No.:** 4

**Assessment:** Acceptable

**Comments:** Agricultural ROW, Interconnect Pipeline. The ROW was restored to original contours, successfully revegetated, and free of severe erosion. The pipe yard site was restored, stable, and successfully revegetated. No issues were noted.

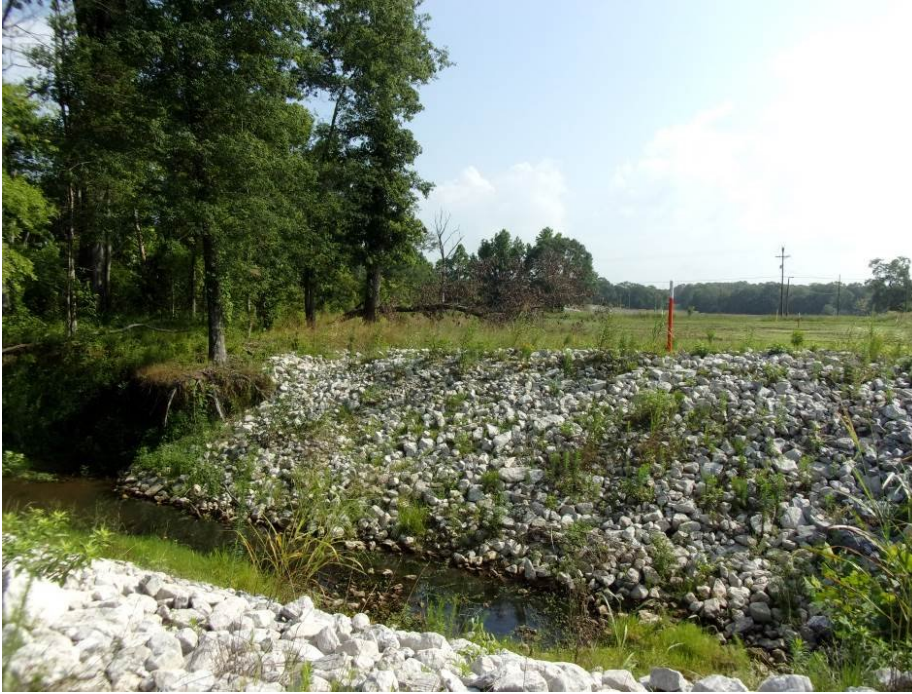
**Photo No.:** 5

**Assessment:** Acceptable

**Comments:** Forested ROW, Interconnect Pipeline, Waterbody S-A-100. The banks were restored and stabilized with riprap, and vegetation was established along the crossing. Downstream flow was unimpeded. The agricultural ROW (background) was restored and in-use by the landowner. No environmental concerns were identified.

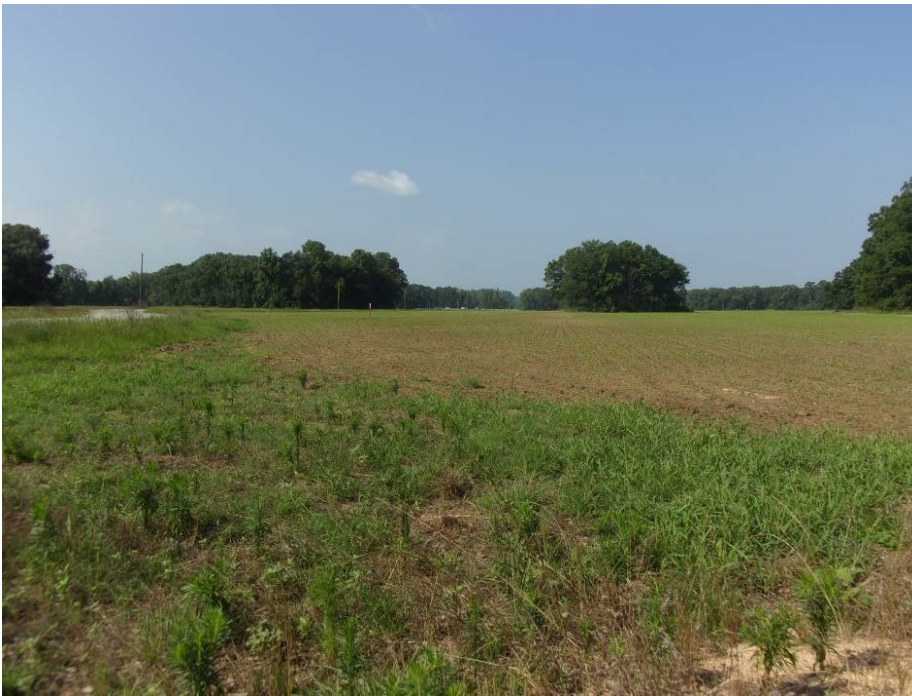
**Photo No.:** 6

**Assessment:** Acceptable

**Comments:** Agricultural ROW, Interconnect Pipeline. The ROW was restored to original contours, stable, and in-use by the landowner. No concerns were observed.

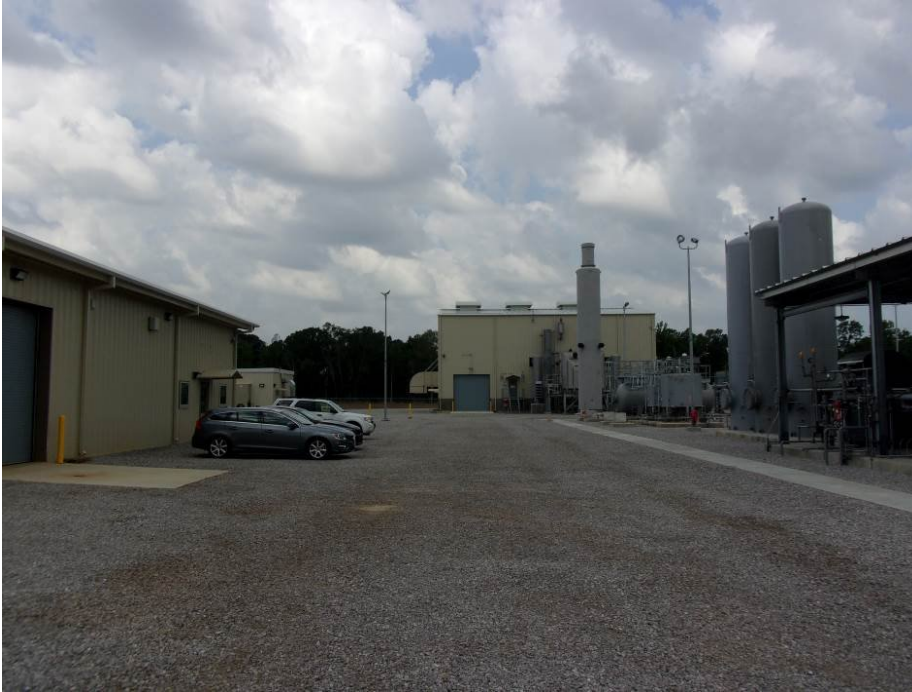
**Photo No.:** 7

**Assessment:** Acceptable

**Comments:** Aboveground Facility, Dentville CS. The compressor, office/warehouse and motor control center buildings were complete. Groundcover gravel was installed around the well-maintained and stable site.

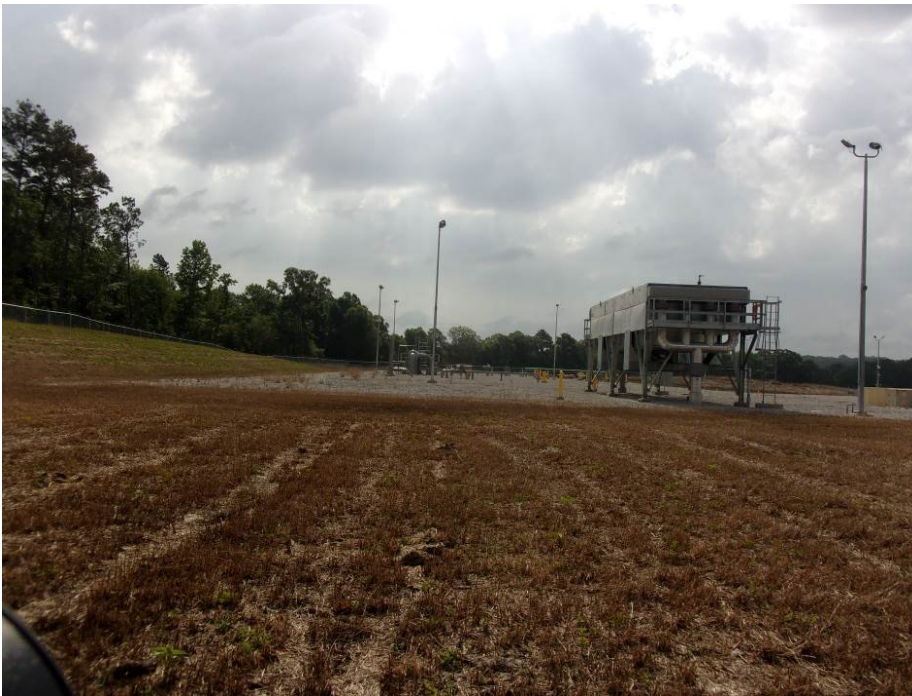
**Photo No.:** 8

**Assessment:** Acceptable

**Comments:** Aboveground Facility, Dentville CS. The sloped hillside along the east perimeter of the site was stable and well vegetated. The annual vegetation was spent, but the yard was stable with no erosion noted.

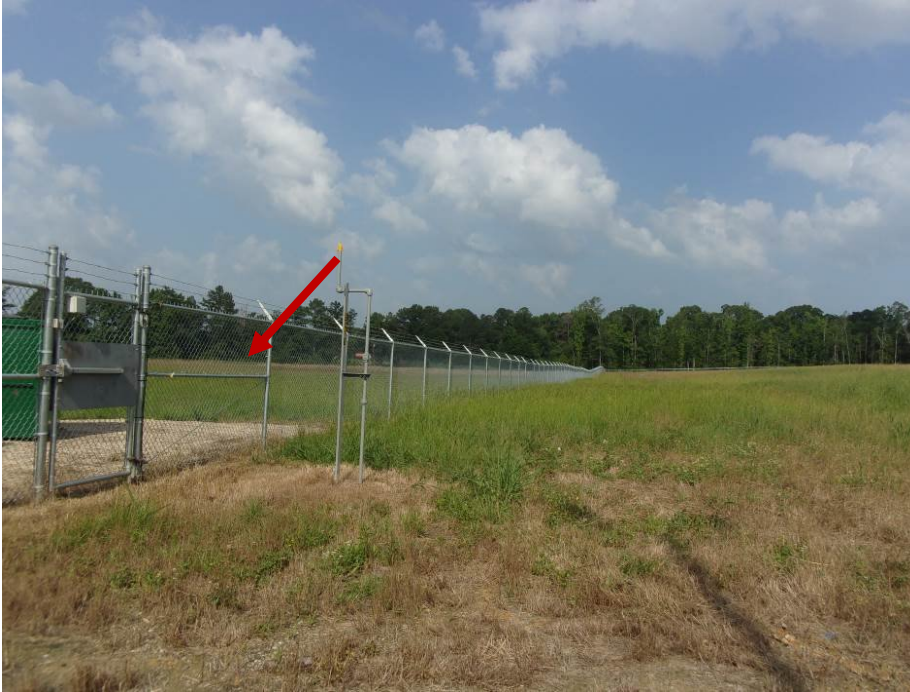
**Photo No.:** 9

**Assessment:** Acceptable

**Comments:** Aboveground Facility, Dentville CS. A chain-linked fence was installed around the entire site perimeter. The contractor yard site (background, red arrow) was restored, stable, and well vegetated. Although the annual vegetation was dying back (foreground), the site was stable, with no erosion or environmental concerns noted.

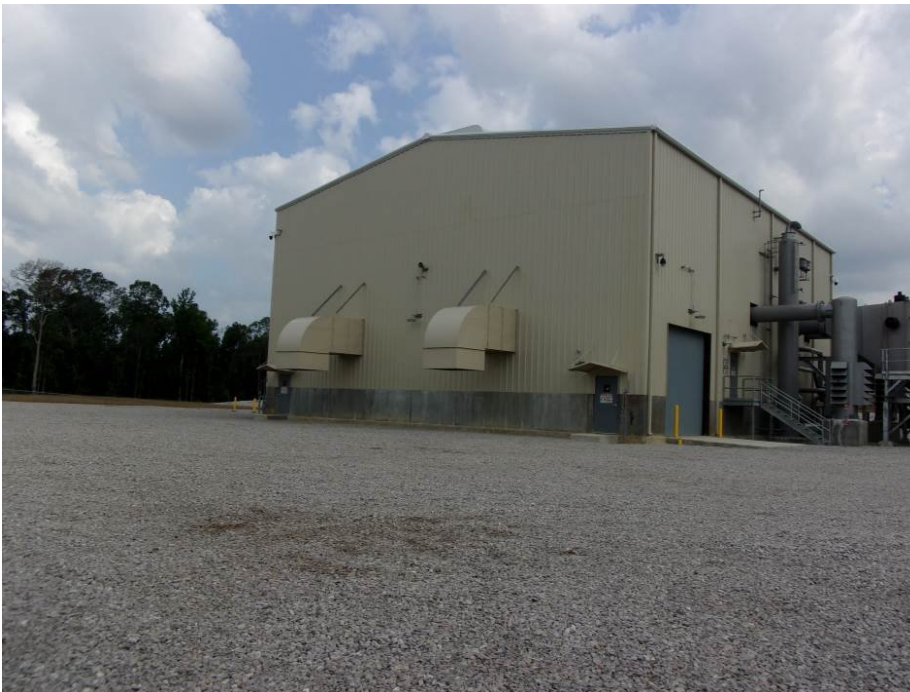
**Photo No.:** 10

**Assessment:** Acceptable

**Comments:** Aboveground Facility, Dentville CS. The compressor station building and components were complete. Gravel groundcover was installed around the entire site. No environmental concerns were observed.
